TEST EXCAVATIONS AT 3LA128

An Early Caddo Occupation on the Red River

FINAL REPORT (Contract Number DACW29-81-M-0165)

Prepared for
U.S. ARMY CORPS OF ENGINEERS
NEW ORLEANS DISTRICT
P.O. Box 60267
New Orleans, Louisiana 70160

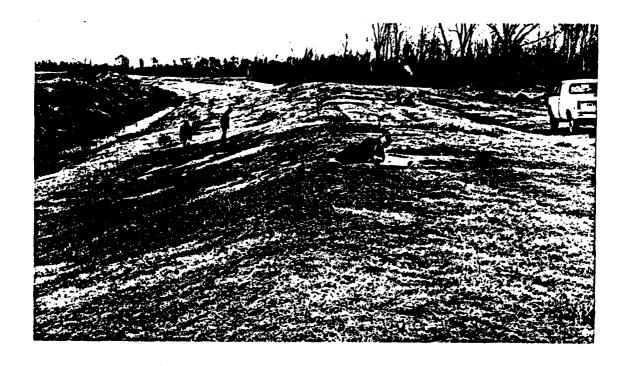
Figure 2. Finished revetment face where the main surface collections were made, looking northeast.

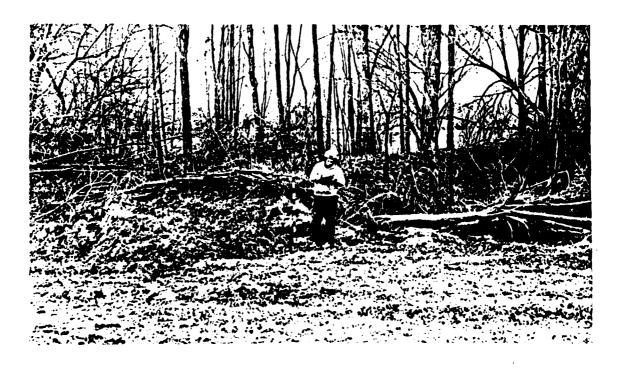
Figure 3. Truncated levee at the northeast end of 3LA128, looking east,

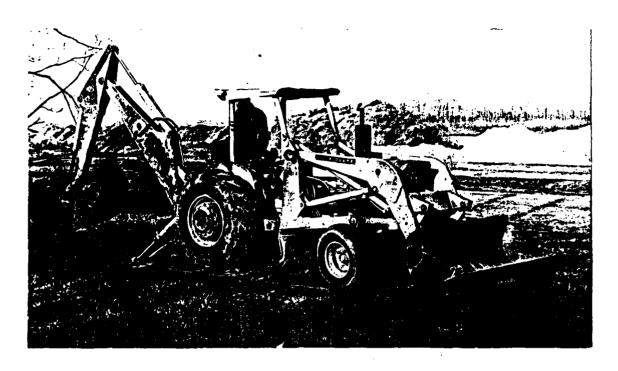
Figure 7. Backhoe opening up backhoe transect #1 segment 7, looking west.

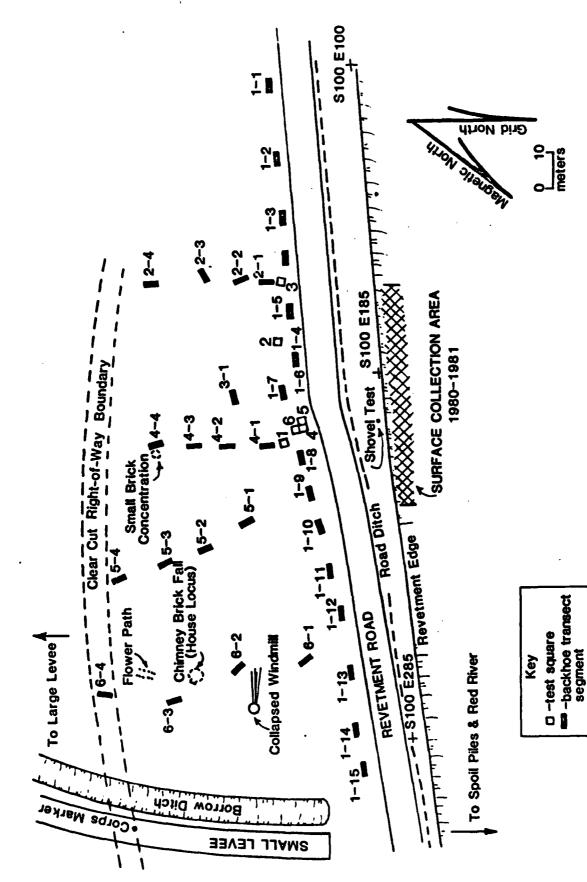
3LA128 site testing map. East-west site limits run between backhoe transect segments 1-1 North-south site limits go from the revetment edge to beyond the right-of-way and 1-15. boundary. Figure 6.

A variety of testing techniques were utilized to investigate the nature and distribution of cultural remains on 3LA128 (Figure 6). Due to the overgrown condition of the site, and based on our experience with the buried deposits at 3LA97, some of the techniques originally proposed for site investigation (surface collection along the revetment edge, shovel testing, and the digging of a distribution of column samples—50 cm square) were not practical. Only small surface collections were made on the revetted bank and on the spoil piles opposite it. Two shovel tests were excavated by hand, but due to the thickness of the overburden on most of the site these small tests and column samples were not cost efficient or sufficiently data productive within the time frame available for the testing. Probing for features was attempted, but the ground was too hard for productive results with this method.

The excavations showed that the aboriginal occupants and the earlier of the two historic occupations had been situated on a rise that tapered off to the east and west along the revetment edge. The site extended for approximately 285 m along the revetment and went beyond the edge of the right-of-way for a rough north-south dimension of 150 m. Beyond the edge of the right-of-way the site was truncated by early twentieth century construction of the levee system that still protects the floodplain. Several sherds were found eroding out of the bank of the borrow area that faces the large levee, marking this destroyed edge of the site. On the far side of the levee another site, 3LA134, found by John Miller in the summer of 1980, may have been on the same rise on which 3LA128 is located. As noted above, on the east side of the site a levee, brick pile, and collapsed metal windmill marked the location of the most recent historic occupation (Figure 6).

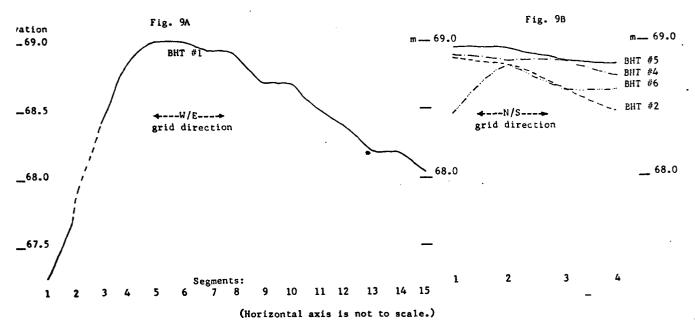
Figure 9. Profiles of the elevation of the midden surface across 3LA128.

Elevations taken from the center of each backhoe trench segment.

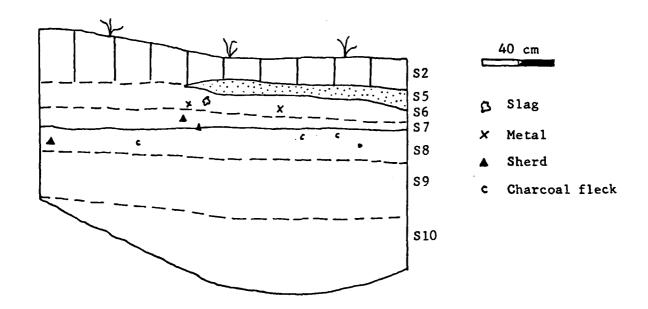
Figure 11. North profile of backhoe transect #1, segment 5. See Table 1 for strata descriptions.

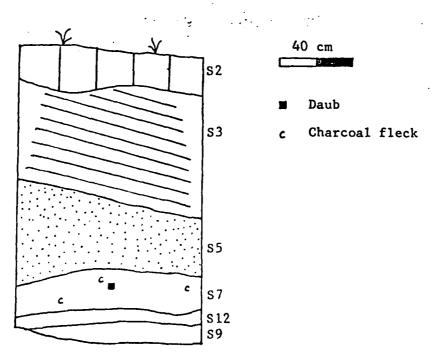
Figure 12. North profile of backhoe transect #1, segment 1. See Table 1 for strata descriptions.

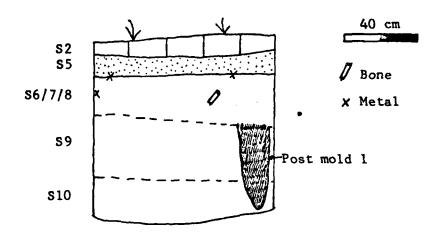
Figure 13. West profile of backhoe transect #2, segment 1. See Table 1 for strata descriptions.

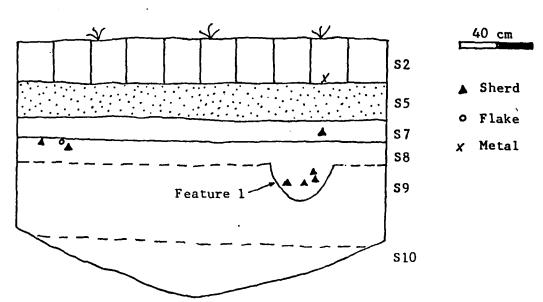
Figure 14. North profile of backhoe transect #1, segment 7. See Table 1 for strata descriptions.

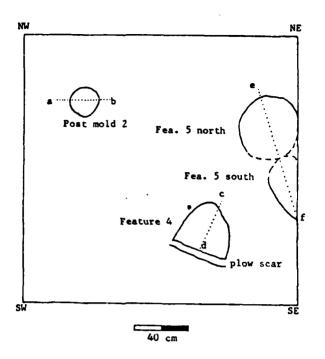
Figure 15. Floor plan of test unit 2. Elevation ca. 68.71 m.

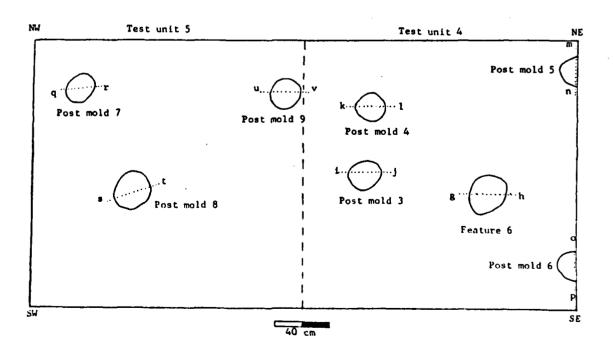
Figure 16. Floor plan of test units 4 and 5. Elevation ca. 68.50 m.

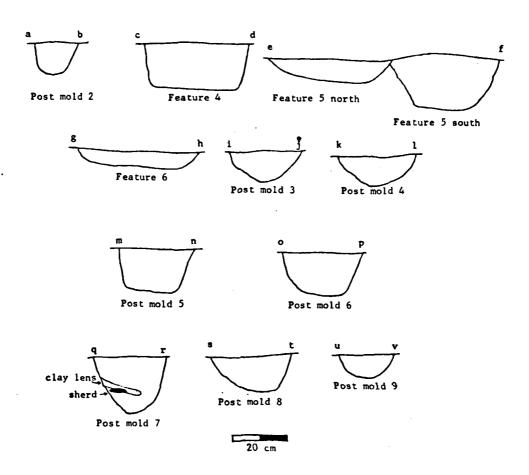
Figure 17. Examples of feature profiles.
